APPENDIX C2
ARBORIST REPORT

ARBORIST REPORT
FOR THE
ALLEN AND CATARACT WAREHOUSE PROJECT
CITY OF SAN DIMAS, LOS ANGELES COUNTY, CALIFORNIA

16431 Scientific Way
Irvine, CA 92618
Phone: (949) 788-4900, Fax: (949) 788-4901
UltraSystems Environmental, Inc. Project No. 7128
Assessor Parcel Numbers 8392-016-008, 8392-016-047, & 8392-016-048

AUGUST 4, 2022

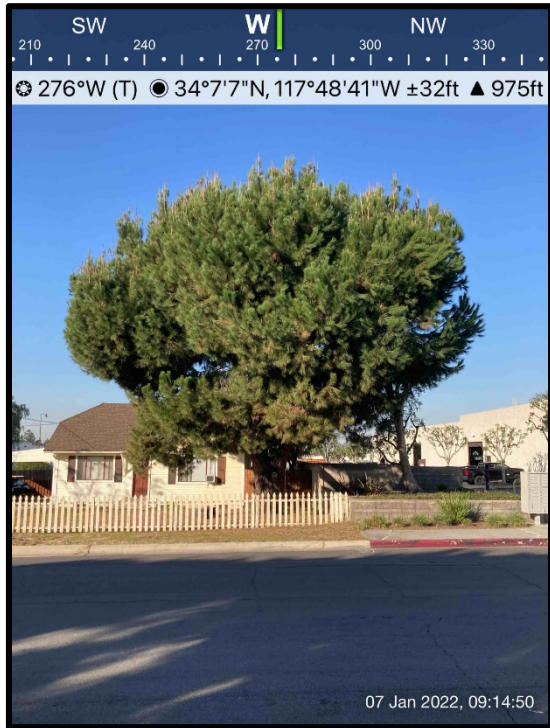
PHOTO 1: West facing view of Tree MST1, a bishop pine tree that will be protected in place. Date: January 7, 2022.

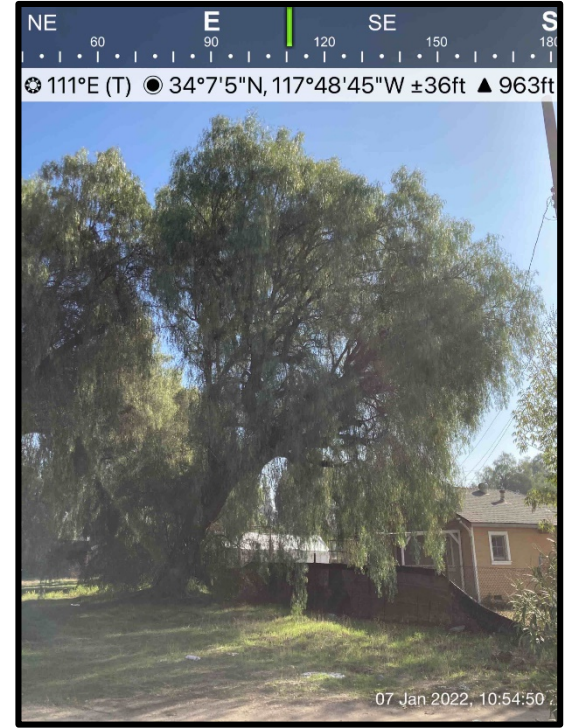
PHOTO 2: East facing view of Tree MST2, a Peruvian pepper tree. Date: January 7, 2022.

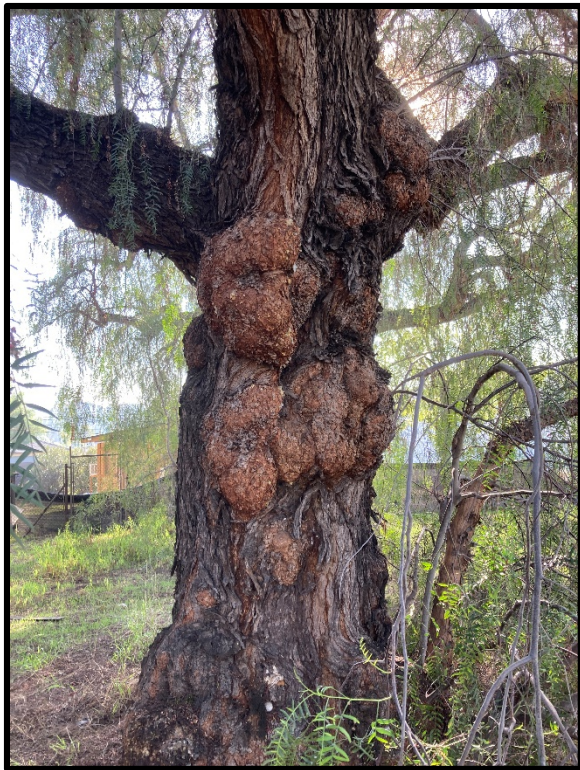
PHOTO 3: Fungus observed growing on Tree MST3, a Peruvian pepper tree. Date: January 7 2022.

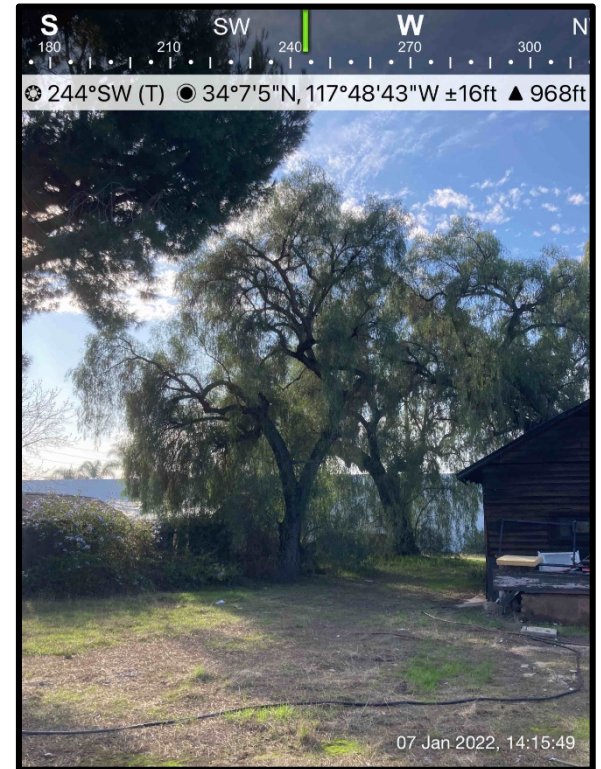
PHOTO 4: Southwest facing view of Tree MST4, a Peruvian pepper tree. Date: January 7, 2022.

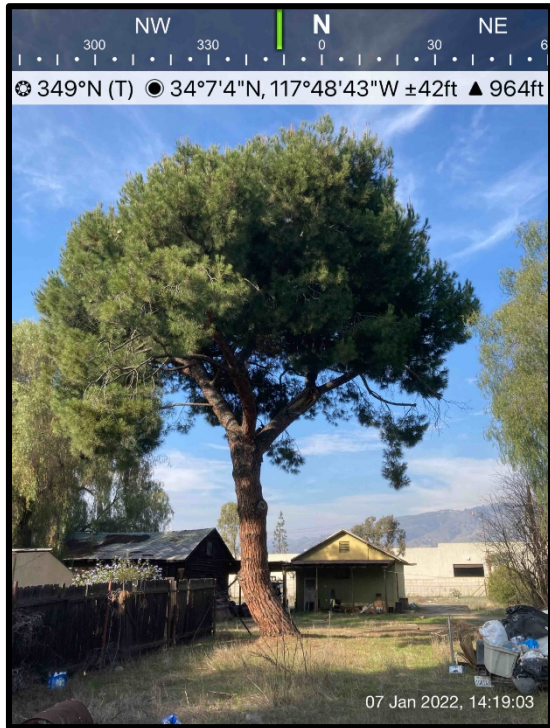
MST5	Removal	Bishop pine	<i>Pinus muricata</i>	34.11814077	-117.8120877	1	33.8	54.4	64.9	166.2	4	Healthy crown structure. Pruned up to 20' height. Rot and stripped bark on main branch.
MST6	Removal	Peruvian pepper tree	<i>Schinus molle</i>	34.11811818	-117.8119175	3	34.7	49.2	55.9	148.2	3	Major branch fallen and is growing parallel to ground. Otherwise healthy. Flowering.
MST7	Removal	Peruvian pepper tree	<i>Schinus molle</i>	34.11822165	-117.8118967	1	42.1	29.1	45.4	118.8	3	Two large branches have fallen. Canopy is unevenly balanced.
MST8	Removal	Peruvian pepper tree	<i>Schinus molle</i>	34.11821223	-117.8118387	1	30.7	65.4	56.1	140.4	5	Healthy branch structure.
MST9	Removal	Peruvian pepper tree	<i>Schinus molle</i>	34.1180613	-117.8118434	1	37.3	65.5	59.9	165.1	5	Healthy branch structure.
MST10	Removal	Peruvian pepper tree	<i>Schinus molle</i>	34.11808695	-117.8115703	1	29.0	41.1	46.4	99.7	4	Several cankers at base of trunk. Large branch has sheared off of tree.

PHOTO 5: North facing view of Tree MST5, a bishop pine. Date: January 7, 2022.

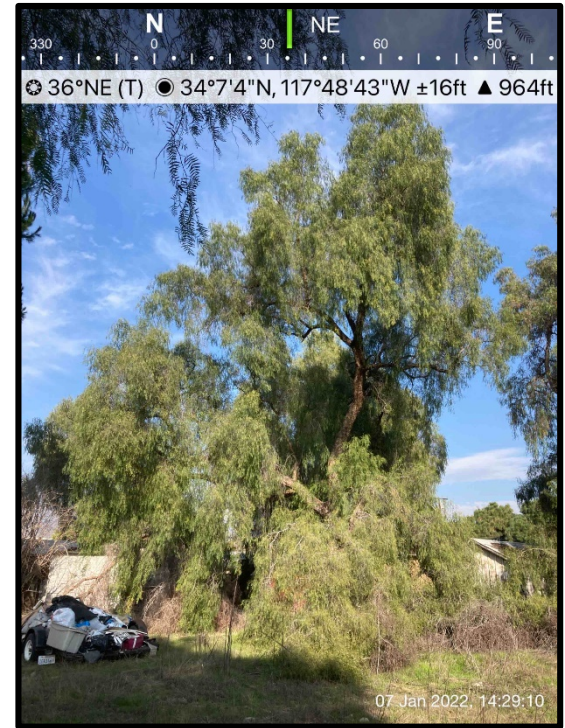
PHOTO 6: Northeast facing view of Tree MST6, a pepper tree. Date: January 7, 2022.

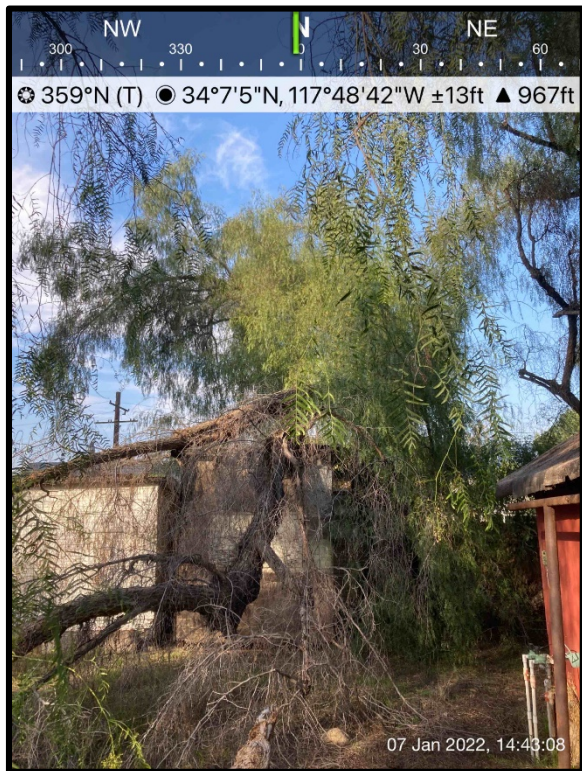
PHOTO 7: North facing view of Tree MST7, a pepper tree. Date: January 7, 2022.

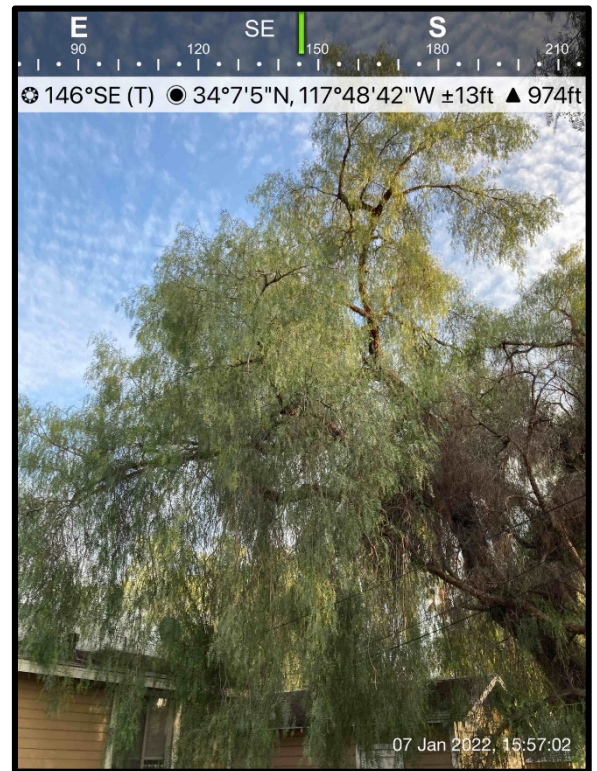
PHOTO 8: Southeast facing view of Tree MST8, a pepper tree.. Date: January 7, 2022.

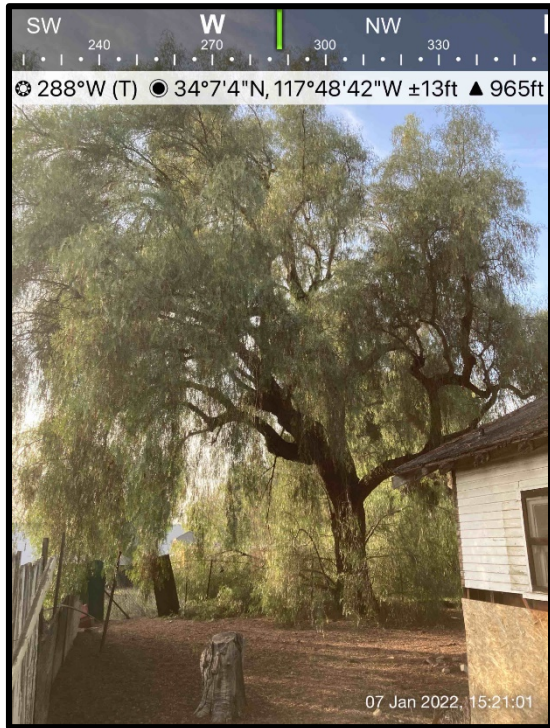
PHOTO 9: West facing view of Tree MST9, a pepper tree. Date: January 7, 2022.

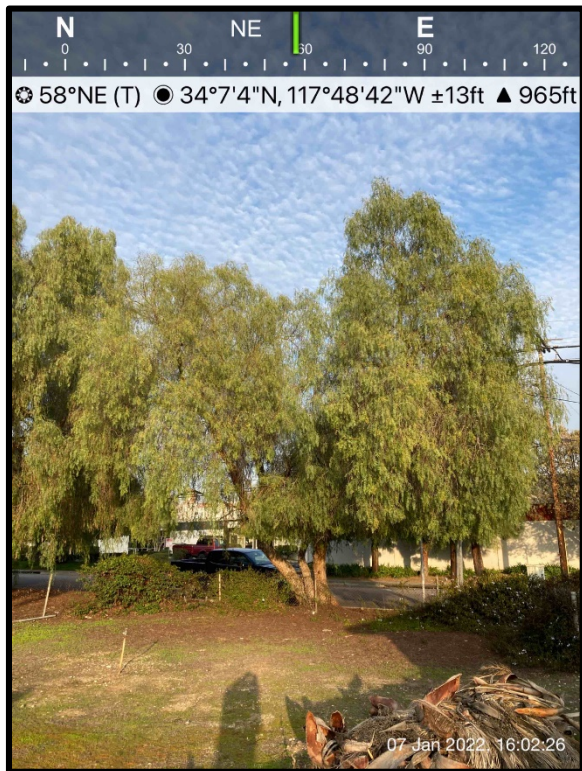
PHOTO 11: Northeast facing view of Tree MST12, a pepper tree. Date: January 7 2022.

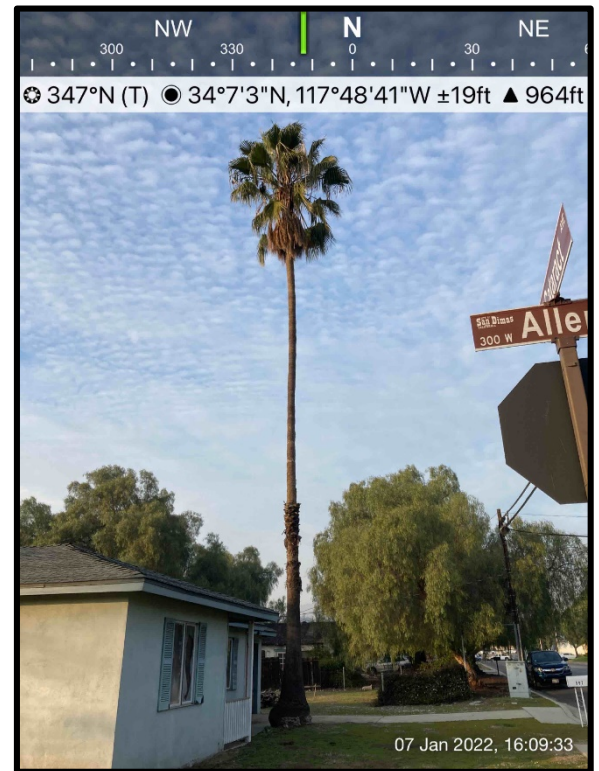
PHOTO 12: North facing view of Tree MST13, a Mexican fan palm. Date: January 7, 2022.

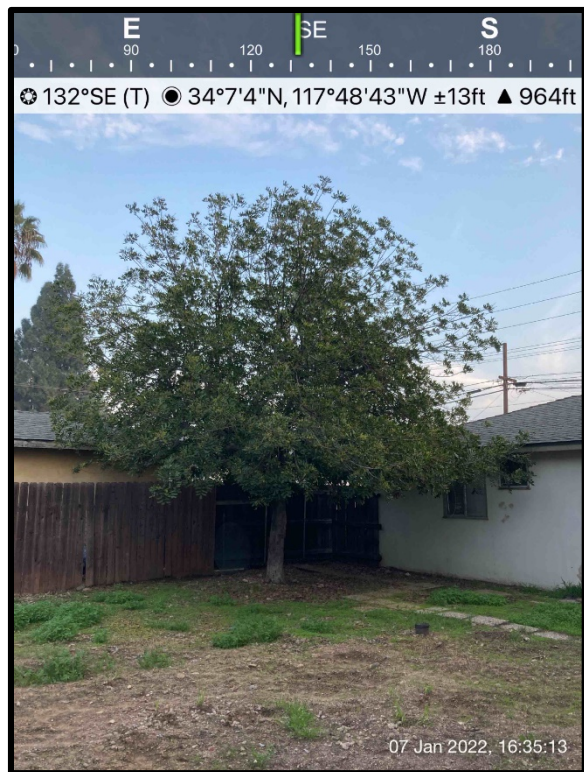
PHOTO 13: Southeast facing view of Tree MST14, a carrotwood tree. Date: January 7, 2022.

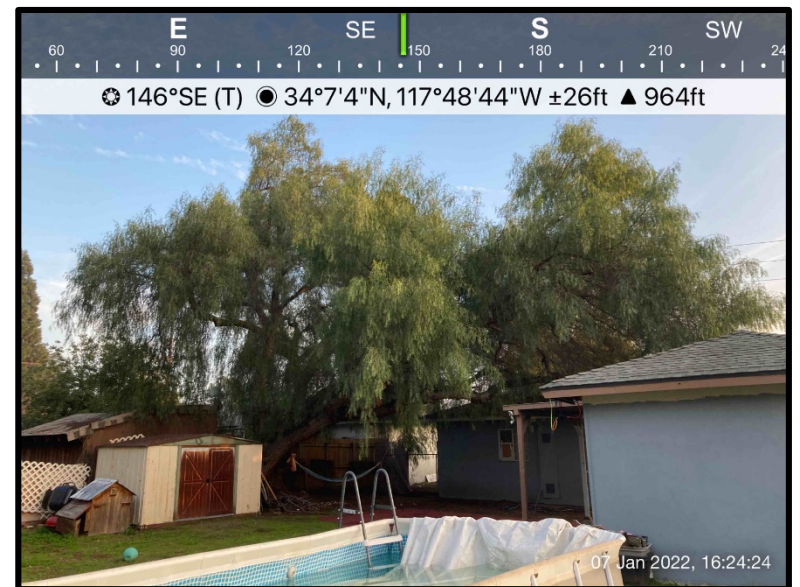
PHOTO 14: Southwest facing view of Tree MST15, a pepper tree. Date: January 7, 2022.

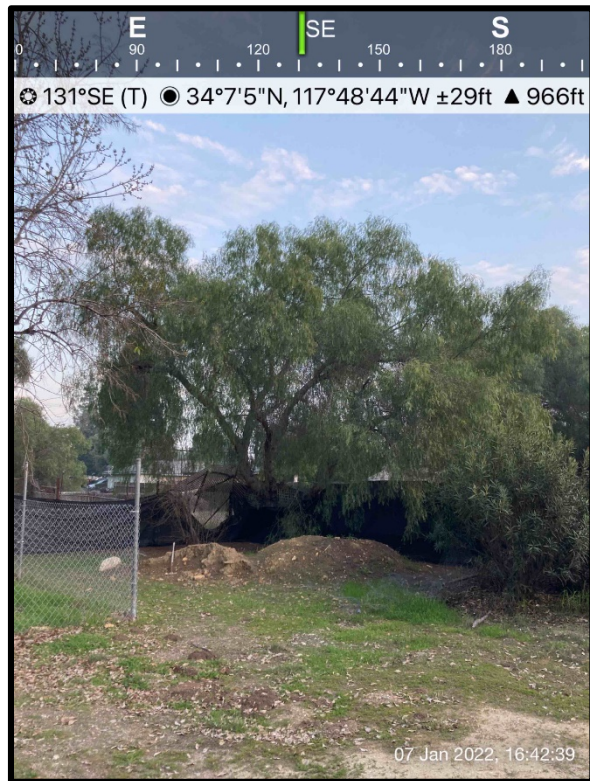
PHOTO 15: Southeast facing view of Tree MST16, a pepper tree. Date: January 7 2022.

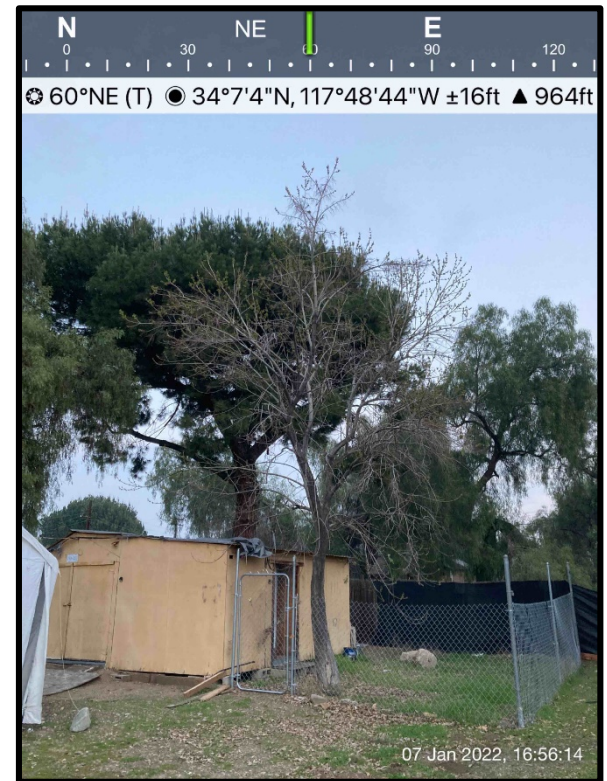
MST17	Removal	white ash	<i>Fraxinus americana</i>	34.11807496	-117.8122041	1	11.0	28.1	19.5	58.6	4	Some stress points at base of trunk. Healthy canopy structure.
MST18	Removal	white ash	<i>Fraxinus americana</i>	34.1180013	-117.8124494	1	10.2	25.8	18.8	54.8	5	Healthy canopy structure.

PHOTO 16: Northeast facing view of Tree MST17, a white ash. Date: January 7, 2022.

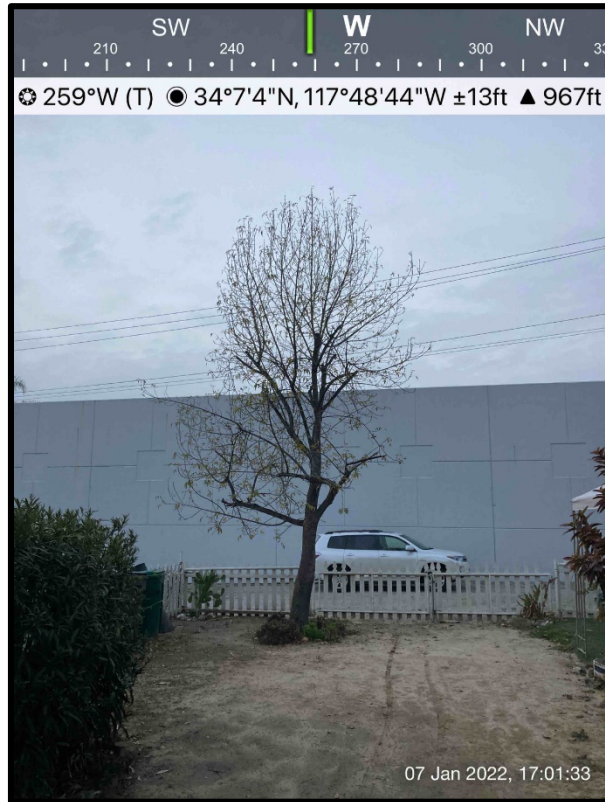
PHOTO 17: Southeast facing view of Tree MST18, a white ash.
Date: January 7, 2022.

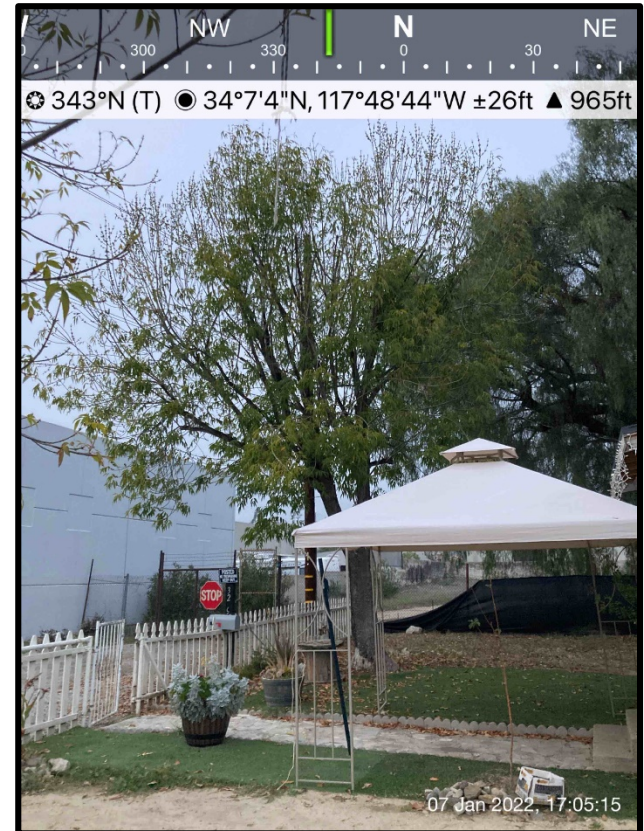
Tree #	Tree Fate	Common Name	Scientific Name	Latitude	Longitude	Number of Trunks	Trunk Diameter (in)	Height (ft)	Canopy Diameter (ft)	Canopy Circumference (ft)	Health & Vigor Rating 1=Dead; 5=Excellent	Comments
MST19	Removal	white ash	<i>Fraxinus americana</i>	34.11810416	-117.812435	1	15.9	27.9	27.9	79.5	5	Damage to bark as base of tree. Healthy canopy structure.

PHOTO 18: Northwest facing view of Tree MST19, a white ash. Date:
January 7, 2022.

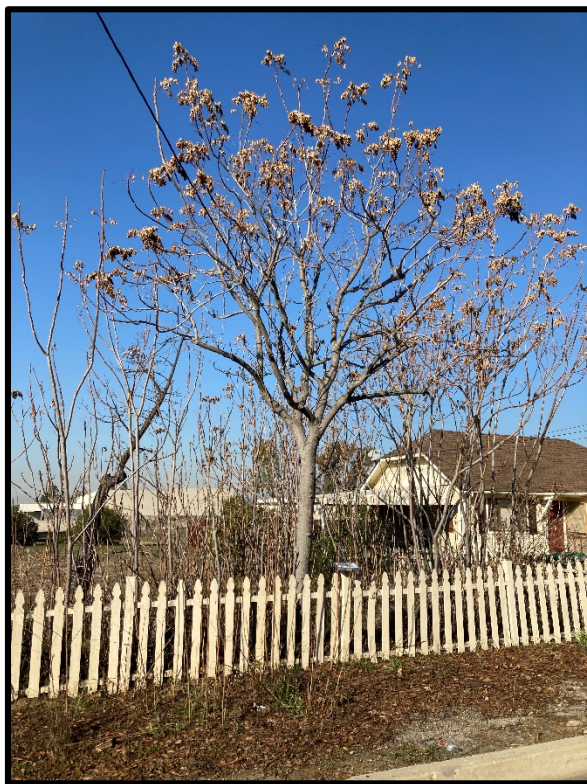
PHOTO 19: Northwest facing view of some of Tree NST5, a
heaven tree and saplings on the eastern edge of the project site,
adjacent to North Cataract Avenue. Date: January 7, 2022.

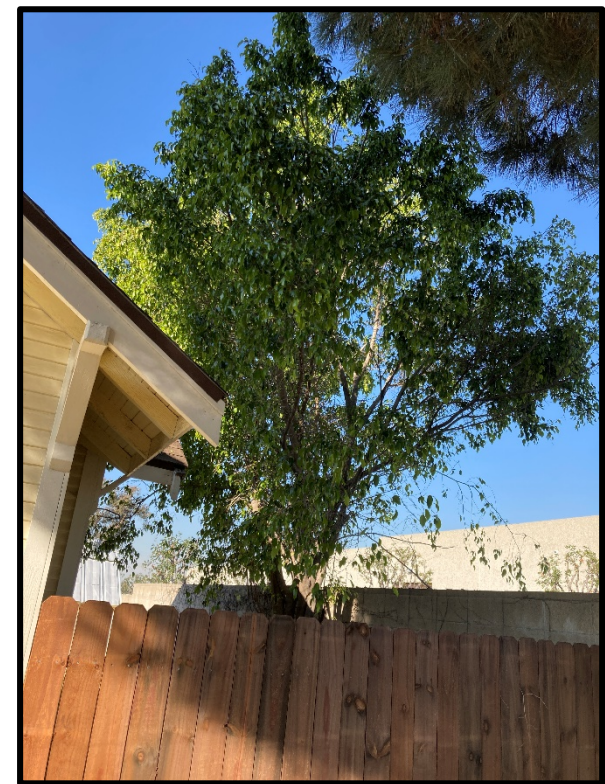
PHOTO 20: Northwest facing view of Tree NST1, a weeping
fig, that is a non-significant tree. Date: January 7 2022..

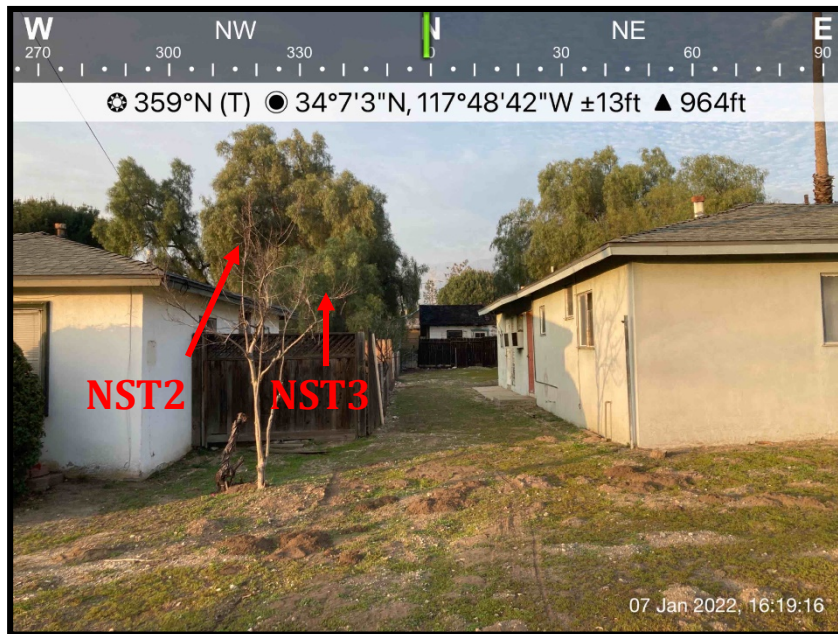
PHOTO 21. North facing view of Tree NST2 and Tree NST3, two pepper trees that are both non-significant trees. Date: January 7 2022..

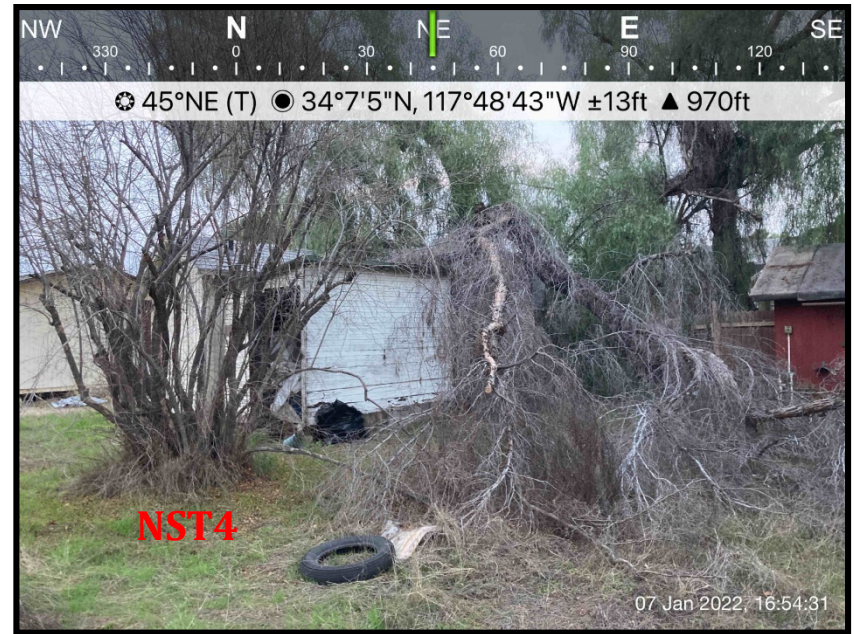
PHOTO 22. Northeast facing view of Tree NST4, a pomegranate tree that is a non-significant trees. Date: January 7 2022..
