APPENDIX D3 HISTORICAL ASSESSMENT

MEMORANDUM

Subject: Historic Significance Evaluation, 309-325 West Allen Avenue and 907-929 North

Cataract Avenue, Allen/Cataract Warehouse Project, City of San Dimas, Los Angeles

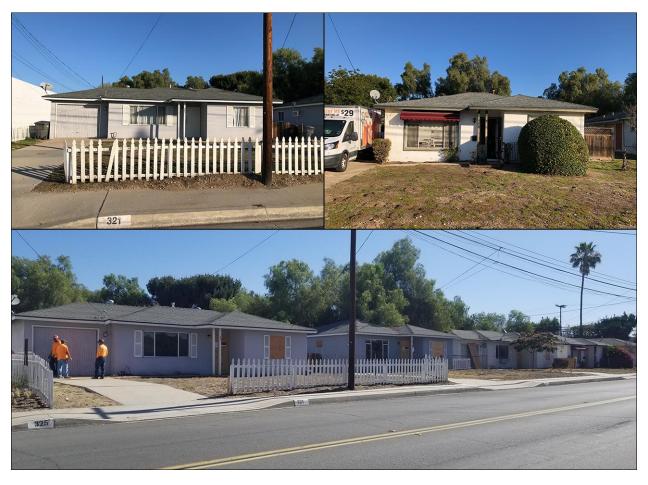
Of the five single-family residences along Allen Avenue, three were built with attached garages, such as 321 W. Allen Avenue (top left; view to the north), and two were not, such as 309 W. Allen Avenue (top right, view to the north). The bottom photo is an overview of the row of residences along Allen Avenue (view to the northeast).

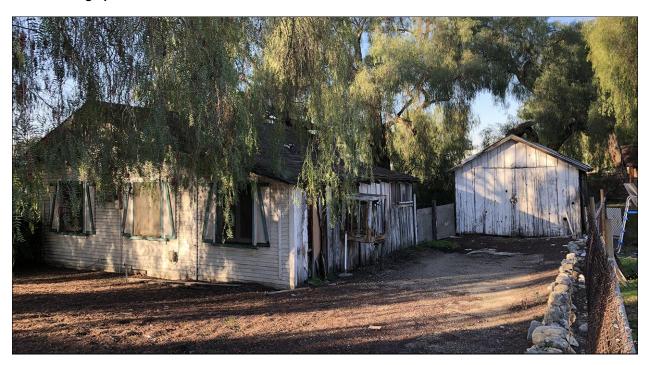
Dating to sometime between 1910 and 1918, the oldest building on the property is the wood-frame bungalow at 911 N. Cataract Avenue, just to the north of the five described above. This house rests at least partially on a rock-and-mortar foundation and has a medium-pitched gable roof that extends at a lower pitch over a lean-to on the north side. The lean-to features mostly board-and-batten exterior walls, while the rest of the house is clad in narrow shiplap siding.

Three evenly spaced, wood-framed casement windows on the street-facing eastern side are set in lug sill trim and flanked by fix shutters decorated with turquoise boards configured into "Z" patterns. A similar casement window is found on the western side, with a few smaller windows. There is no entry on the eastern side, while the other sides have entries that are sealed by particle boards or are empty, except for an unglazed wood door near the northern end of the west side.

This building is now in a completely decrepit condition. It is missing some siding, with the internal frame exposed or covered by particle boards, and has suffered fire damage. A detached single-car garage with a medium-pitched front-gable roof and clad in board-and-batten stands to the northwest of the residence. It is also in a neglected state but remains relatively intact.

Circa 1910-1918 residence and garage at 911 N. Cataract Avenue (view to the southwest)

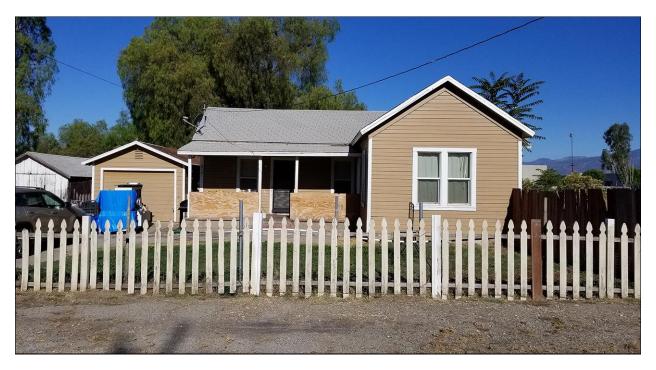
Further to the north, the residence at 917 N. Cataract Avenue, built in the 1910s-1920s, is an L-shaped building set on a raised concrete block foundation and surmounted by a medium-pitched cross-gable roof. The roof is sheathed in gray composition shingles and ends in medium-width eaves with fascia boards. The roof flattens at the rear over a lean-to and at the front as well, over the interior of the L, to shelter an elevated porch and two entries, one opening to the east and the other, on the short leg of the L, opening to the south.

The exterior walls are clad in light brown horizontal tongue-and-groove wood siding. Windows consist mainly of wood-framed double-hungs, some of them set in pair, although some untrimmed aluminum-framed sliding windows are also found on the side and rear facades. Another entry is centered at the rear, accessed by three concrete steps. This house is in fair condition.

Circa 1910-1929 residence and garage at 917 N. Cataract Avenue (view to the west)

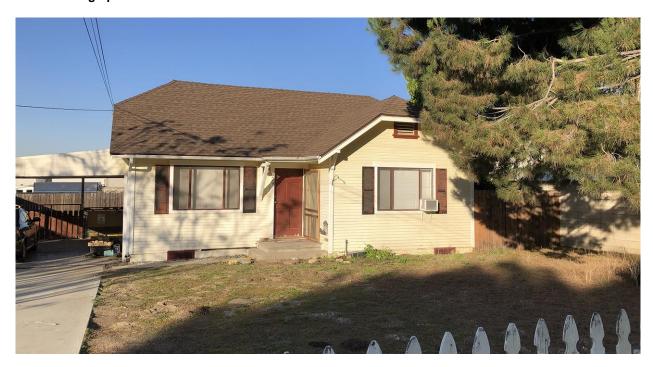
The residence at 929 N. Cataract Avenue dates to around 1953. It rests on concrete block footings and is surmounted by medium-pitched hip-on-gable roof over the main mass, with a lower, front-facing cross-gable over a shallow protrusion that fills the northern portion of the primary (eastern) façade. Another protrusion off-centered at the rear also has a small cross-gable and houses an entry that opens to the south. Dark composition shingles cover the entire roof, which features medium eaves with exposed rafter tails, fascia boards, and decorative triangular backets. Light yellow shiplap siding clads the exterior.

The centered front entry is accompanied by a stepped concrete stoop and a roof extension that forms a small porch. Flanking the entry are two tripart windows, each composed of a large, square fixed sash flanked by two narrow casements. Fixed wood shutters decorate these otherwise untrimmed windows. Windows on the other sides are all sealed with plywood board at this time. A carport is attached to the south side of the house, and an off-white storage shed with a gambrel roof, board-and-batten walls, and a metal front canopy faces south behind the residence.

Circa 1953 residence at 929 N. Cataract Avenue (view to the west)

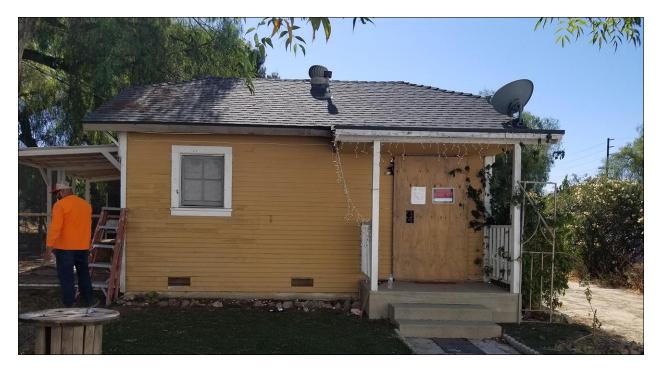
The residence at 325 W. Allen Avenue was moved to the property around 1955 and was placed along a private, unpaved road near the western property boundary. This small residence rests on raised concrete block footings and

*P3a. Description (continued): is surmounted by a medium-pitched hip-on-gable roof of brown composition shingles with medium-width eaves. The roof flattens over a full-length addition at the rear and at the front over an entry porch that occupies the southern portion of the west-facing façade. The overhang has a boxed ceiling supported by a cross beam and two square posts sunk into the concrete floor of the porch. Light yellow shiplap siding clads the exterior. The rear façade has exposed rafter tails under the eave and deteriorated walls that are repaired with particle board. A large shed off the northeast corner has a composition sheet roof and wood panel walls.

Residence at 325 W. Allen Avenue, moved to the property around 1955 (view to the east)

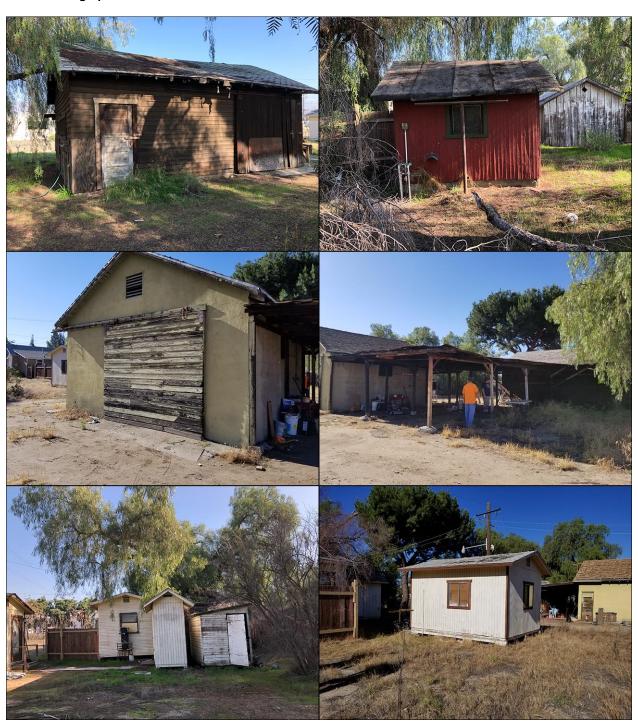
A matching garage that stands a short distance to the southwest was built in around 1962, and about a dozen additional buildings of old but undetermined vintage are scattered behind the residence and garage, including bungalows, sheds, and garages. They are all wood-framed single-story structures, some of them set on concrete block foundations. One has a gambrel roof, while others have medium- or low-pitched gable roofs. The exterior walls are clad with wood siding, either narrow and horizontally placed or wider and vertically placed, or in stucco. At least three of these buildings appear to have also been used for residential purposes in the past, but all are now abandoned or used for storage.

Various views of outbuildings and ancillary structures on the former Prehn family property
